**ANTHROPOMORPHIC CUTANEOUS TACTILE SENSING
ON DEXTEROUS MECHANICAL HANDS**

Allen R. Grahn

**BONNEVILLE SCIENTIFIC, INC.
1849 W. NO. TEMPLE, BLDG. E
SALT LAKE CITY, UT 84116**

FINAL REPORT FOR THE PERIOD JANUARY 1991 TO JUNE 1994

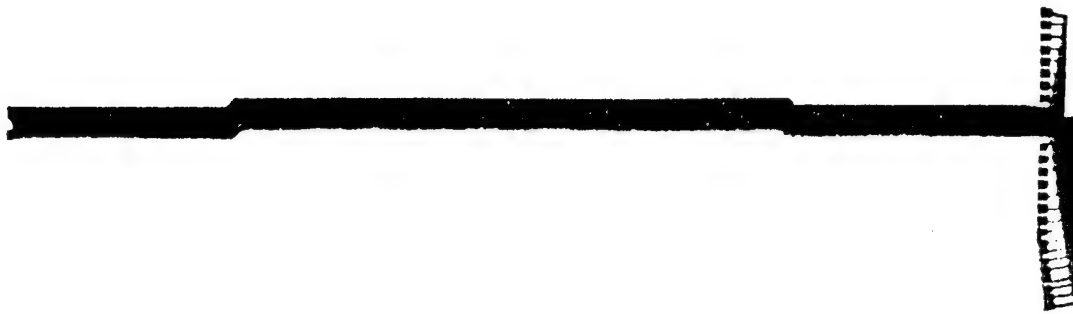
Figure 10. Cables for the three finger segments.
(Only receiving leads shown)

We developed one double-sided cable for the arrays on each digit segment. Leads for the transmitting elements were on one side, and the receiving leads on the other side. Figure 10 shows the receiving leads on one side of these cables for the three segments. A similar arrangement was used for the transmitting leads that are on the opposite side of the cables.
